Drawing Title
Existing Roof Photographs
w New Work Scope Notes

Project Title
Building No. 6 - Re-roof

Location
VA Medical Center, Milwaukee, WI

Drawing Number
A302

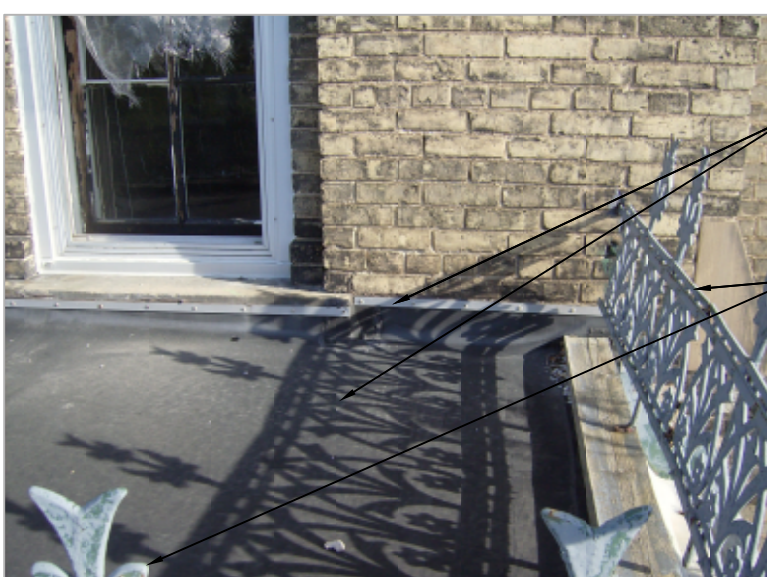
P71 EAST EDGE OF FRONT ENTRY PORCH C-WING (SOUTH SIDE)

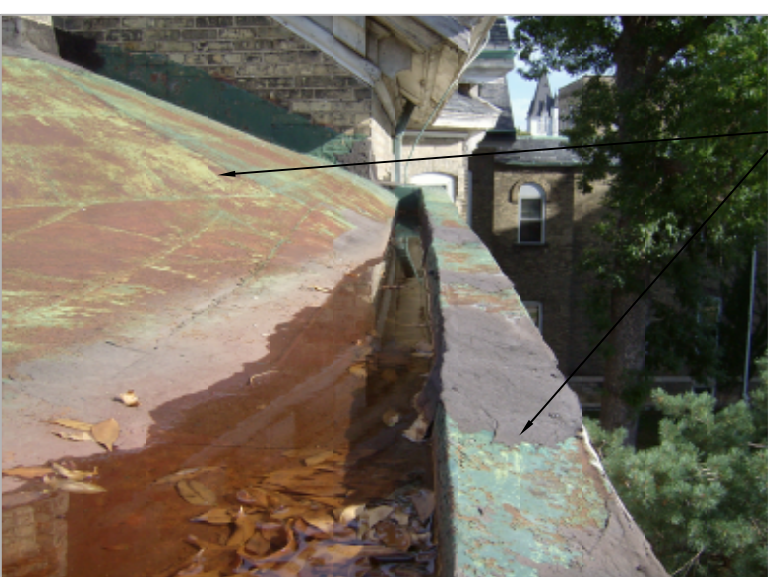
P77 EAST EDGE OF ROOF OVER ENCLOSED PORCH AT SOUTH END OF B-WING

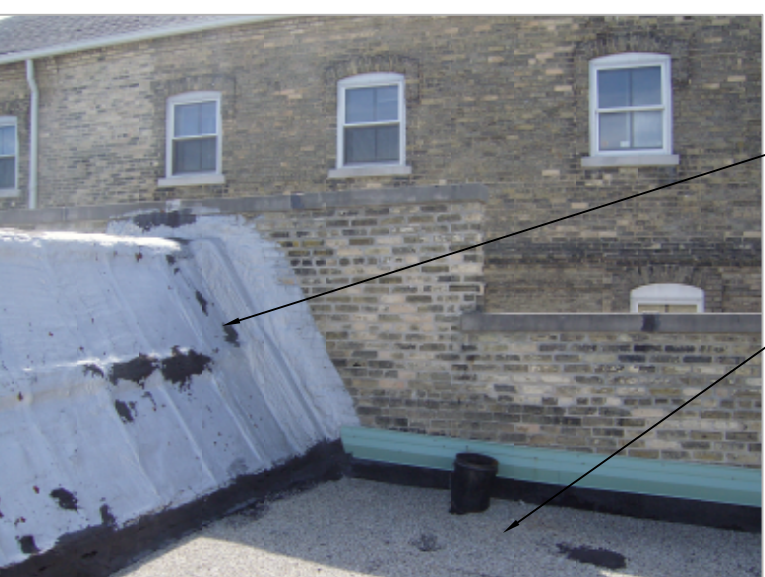
P83 WEST SIDE OF LOW-SLOPE ROOF AREA 'E1-A' (LOOKING SOUTH)

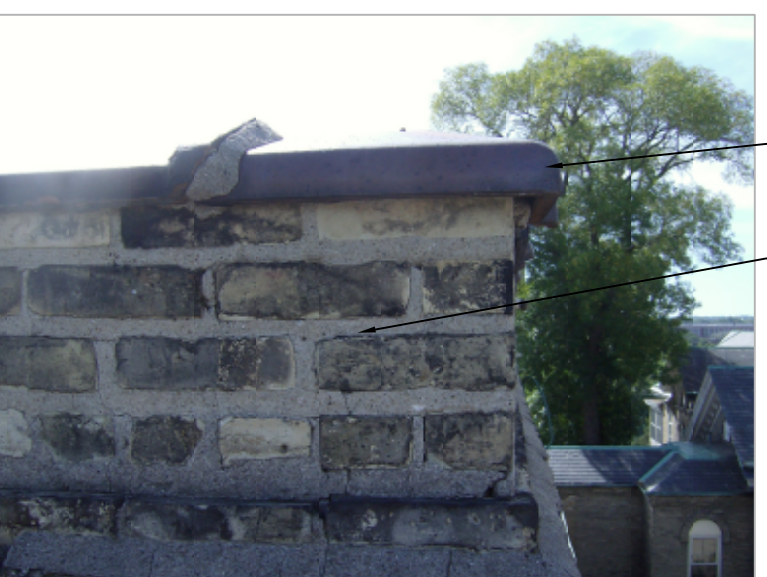
P95 EXTERIOR PARAPET OF ROOF 'E5' ON NORTH SIDE OF C-WING [REFER TO SHEET A100]

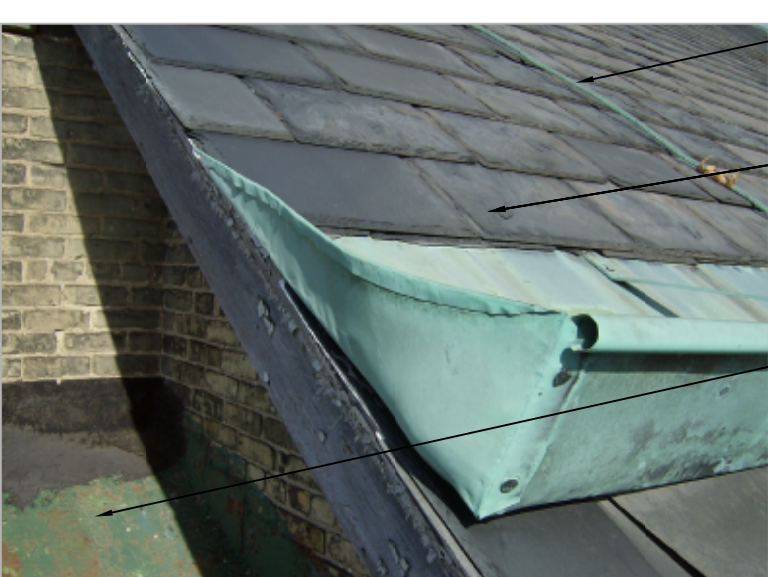
P73 EAST EDGE OF FRONT ENTRY PORCH C-WING [ENLARGED PHOTO OF CONDITIONS ABOVE]

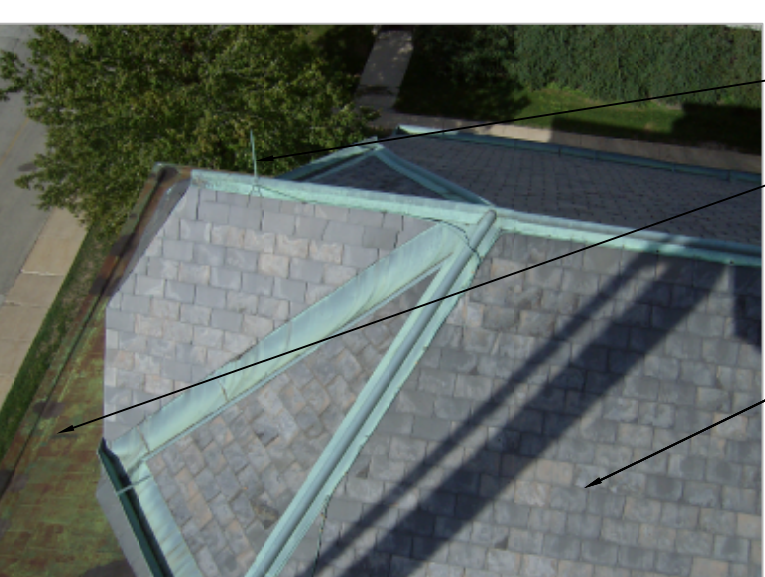
P79 GUTTER END ADJACENT TO ROOF OVER ENCLOSED PORCH AT SOUTH END OF B-WING

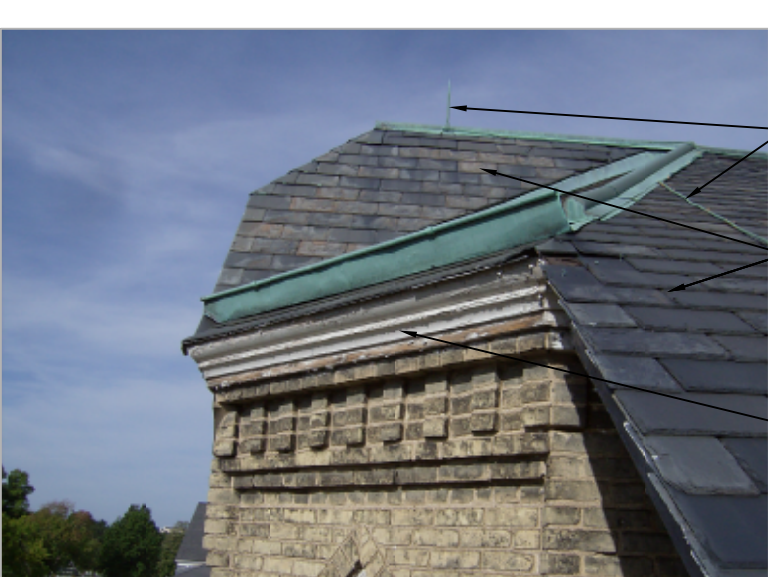
P74 LOW-SLOPE ROOF AREAS BEHIND C-WING

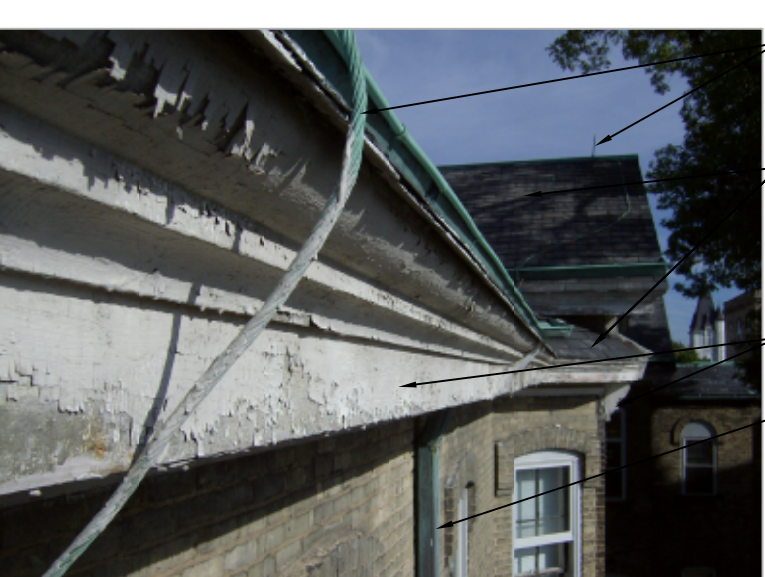
P80 COMPOUND HIP ROOF CONDITION AT SOUTH END OF B-WING

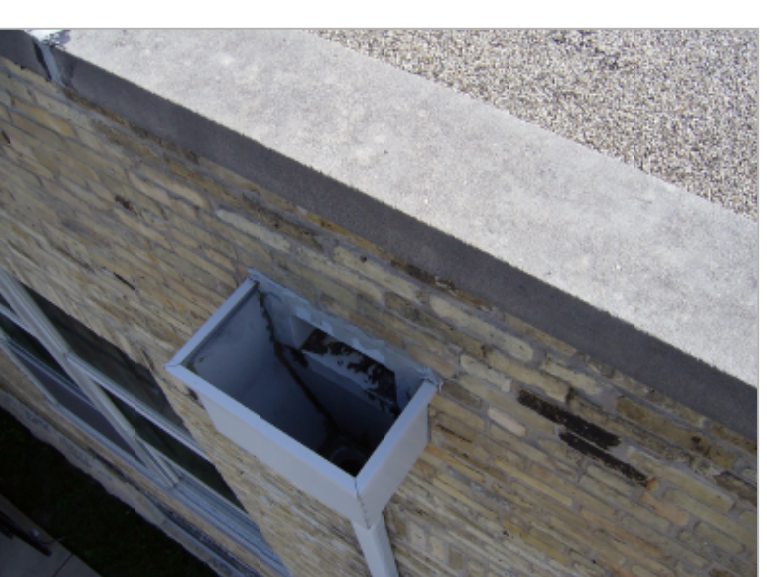
P86 WEST SIDE OF B-WING (LOOKING NORTH)

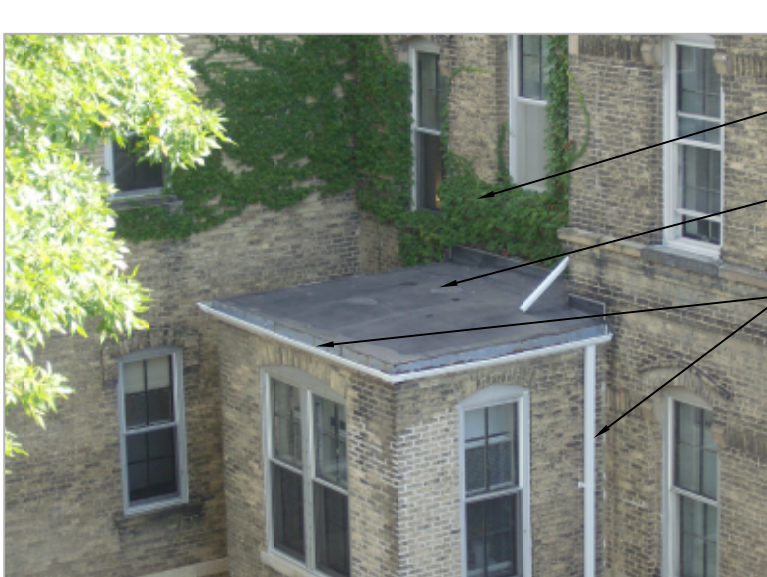
P104 COMPOUND EAVE CONDITION ON WEST SIDE OF D-WING

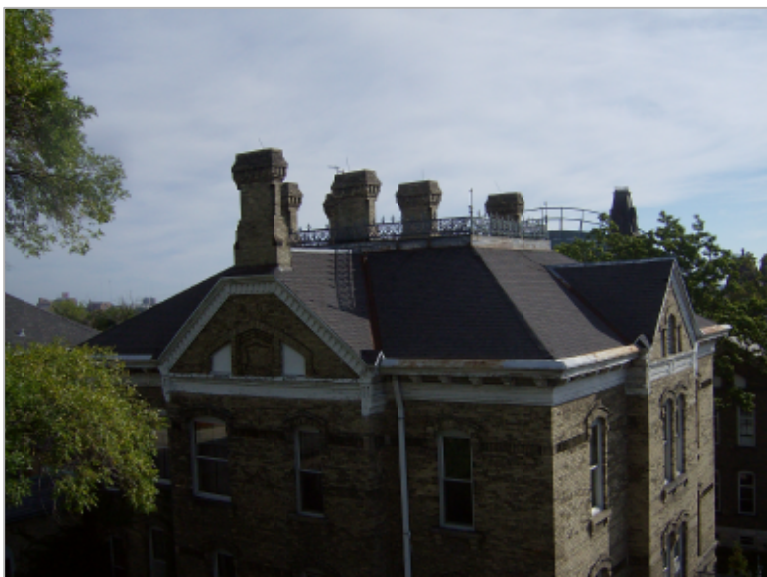
P105 EAVE CONDITION ON WEST SIDE OF D-WING

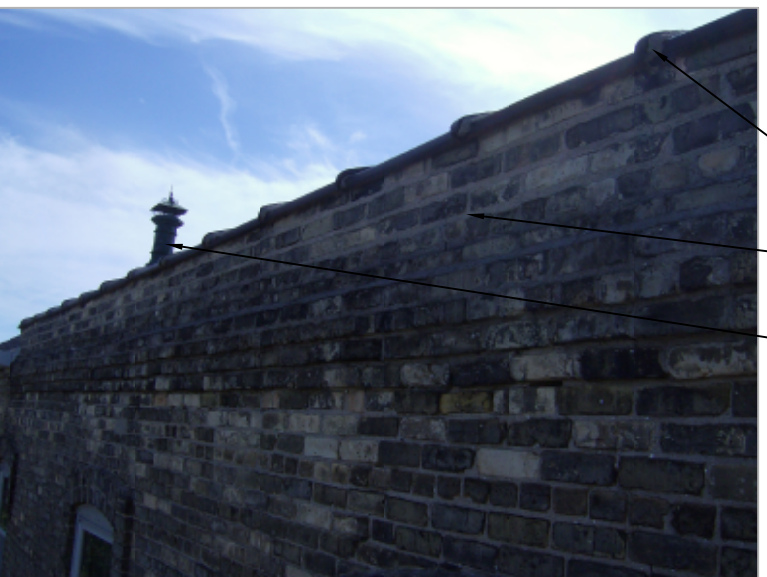
P88 ENLARGED AERIAL VIEW OF CHIMNEY CAP ABOVE (LOOKING NORTHWEST)
